LINE OF DUTY DEATH REPORT

REPORT 2021-10 • December 2024

Volunteer Firefighter Killed after Becoming Trapped at an Assisted Living Facility Fire and Two Firefighters Injured – New York

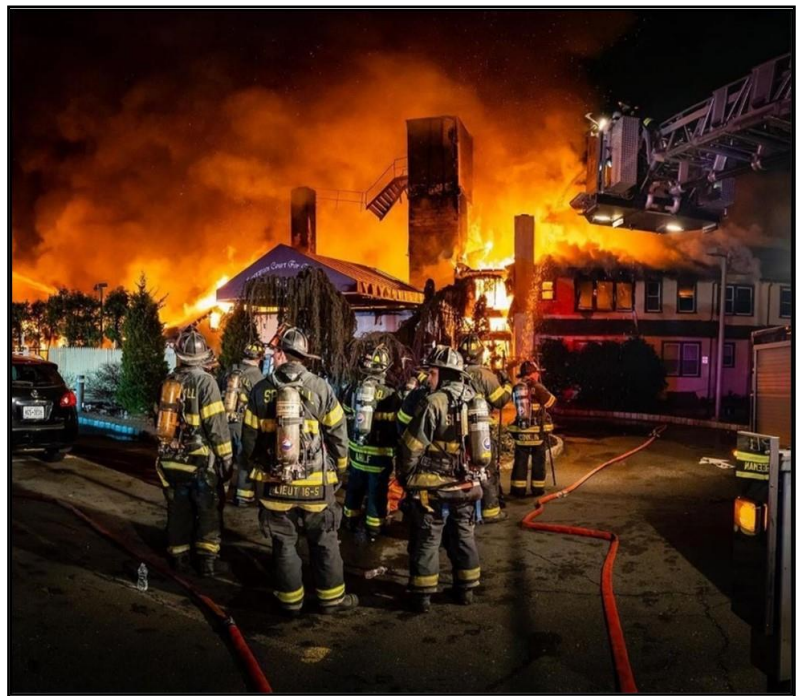
The collapse of Side Alpha/Side Bravo corner at 03:01 hours of the assisted living facility.
(Photo courtesy of Kenneth Flynn)

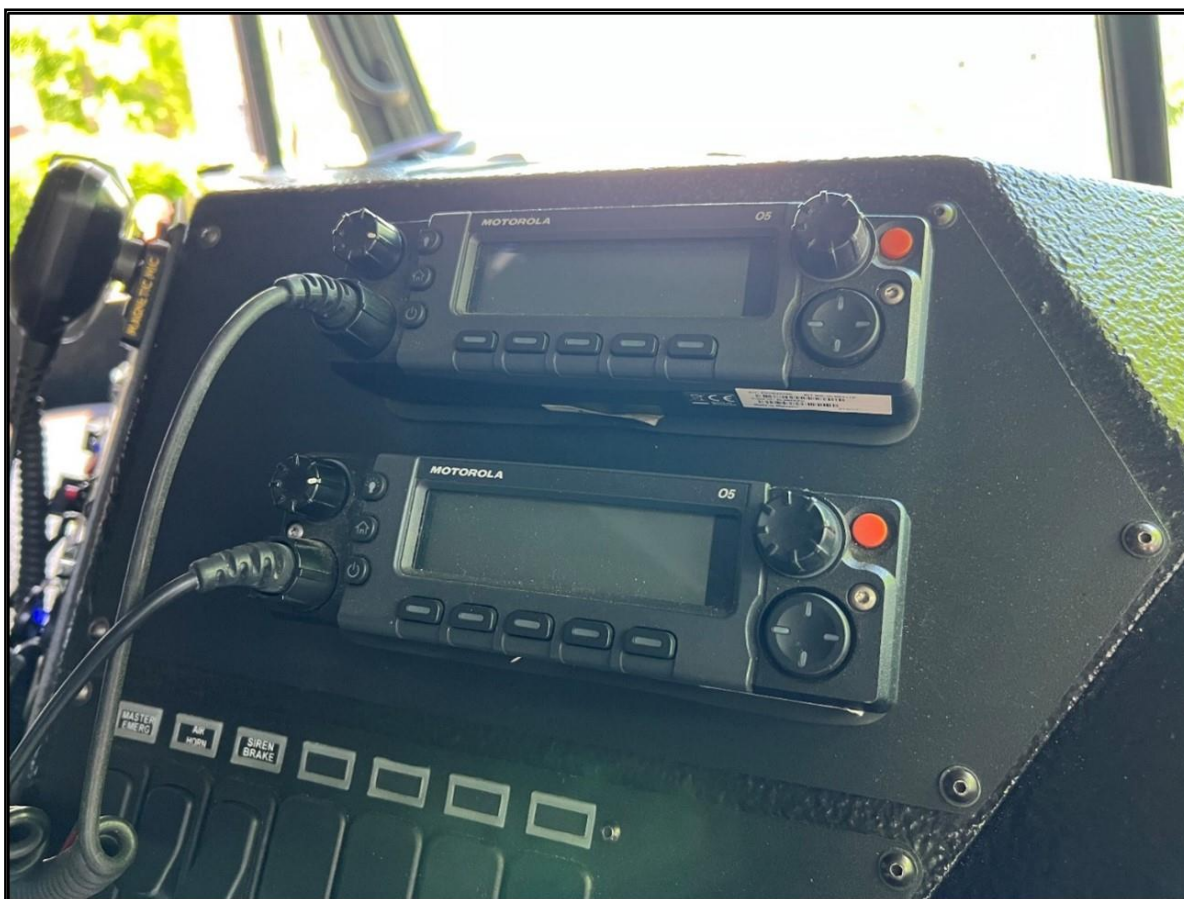
**Photo 1. The radio console in the cab of Tanker 17 showing the UHF mobile radio and 700 MHz mobile radio.
(NIOSH Photograph)**

The Communications Division operates six tactical channels on ultra-high frequency (UHF) on 464 or 465 megahertz (MHz). Fire departments are dispatched on a trunked system on 700 MHz frequency (**See Photo 1**). Portable radios that operate on the 700 MHz have an emergency alert button (EAB). When the EAB is activated, the radio channel is programmed to go to the fire dispatch channel (i.e., Fire 1). Most of the fire departments use an APX 6000 portable radio with a scan function. The majority of portable radios operate on the fireground tactical channels only and are not programmed to talk on Fire 1. Throughout the county, the Communications Division operates 12 repeater towers and 100+ buildings distribute antennas.

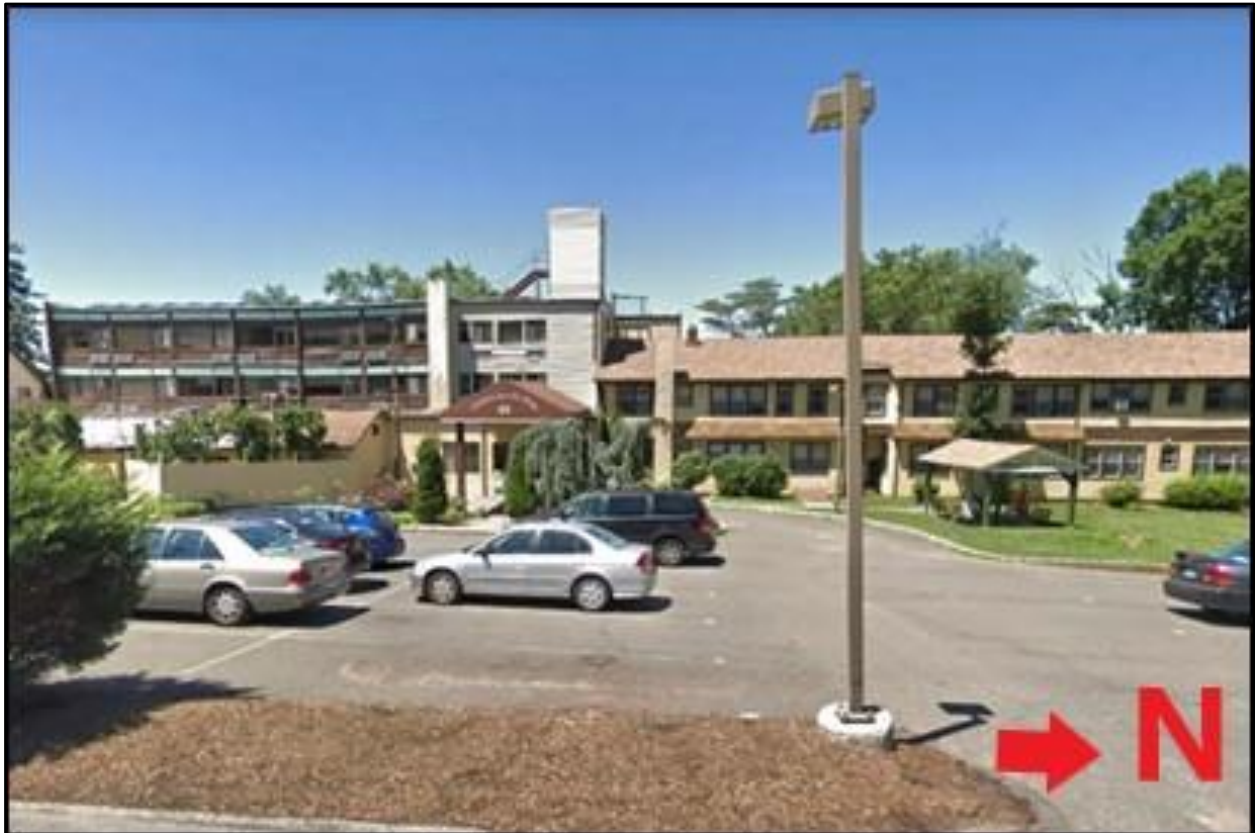
Photo 2. Side Alpha of the assisted living facility.
(Photo courtesy of the New York Post)

building construction were limited or non-existent. This includes the overall plot plan of the facility and dimensions of the buildings. The original set of buildings were wood frame (Type V) building construction (See **Photo 2** and **Photo 3**).

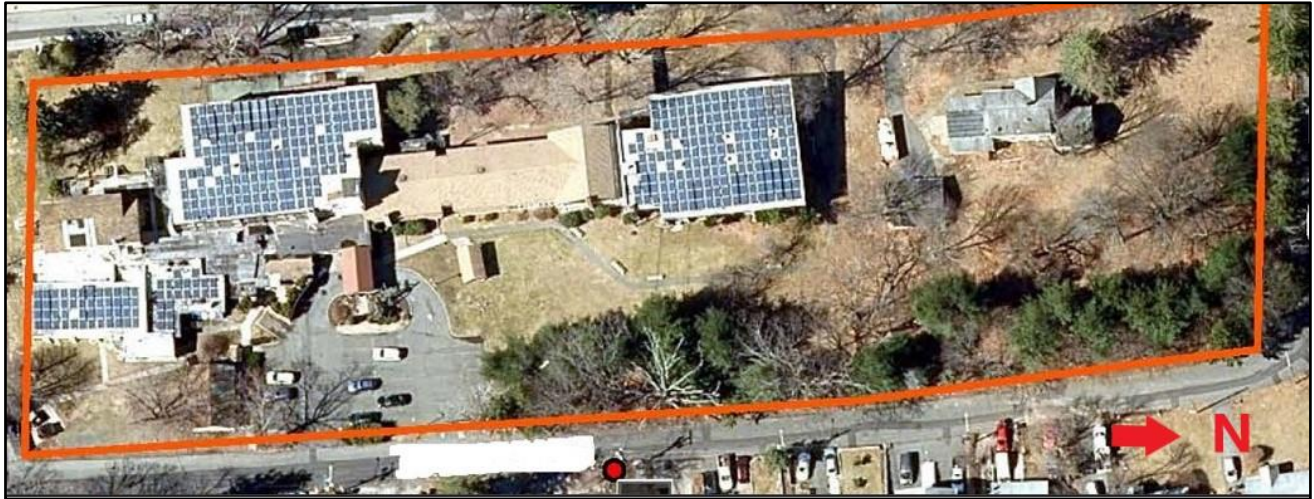
Photo 3. An aerial photograph of the assisted living facility. The red dot at the bottom of the picture indicates the closest fire hydrant.
(Photo courtesy of the county Fire Academy)

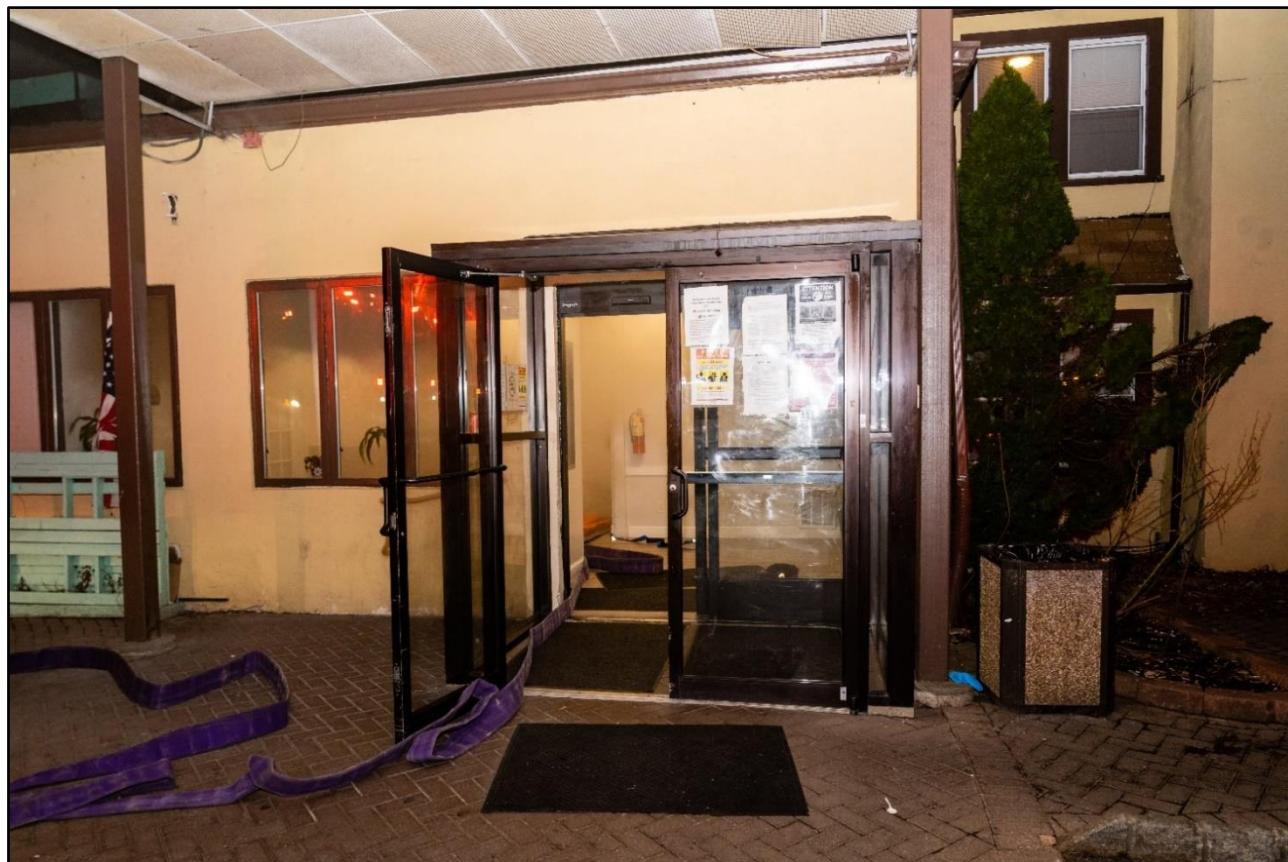
Photo 4. Photograph of smoke condition observed in the lobby. The 3-inch hoseline from Tanker 17 was stretched up the stairwell to the 2nd floor. The time was approximately 01:12 hours.

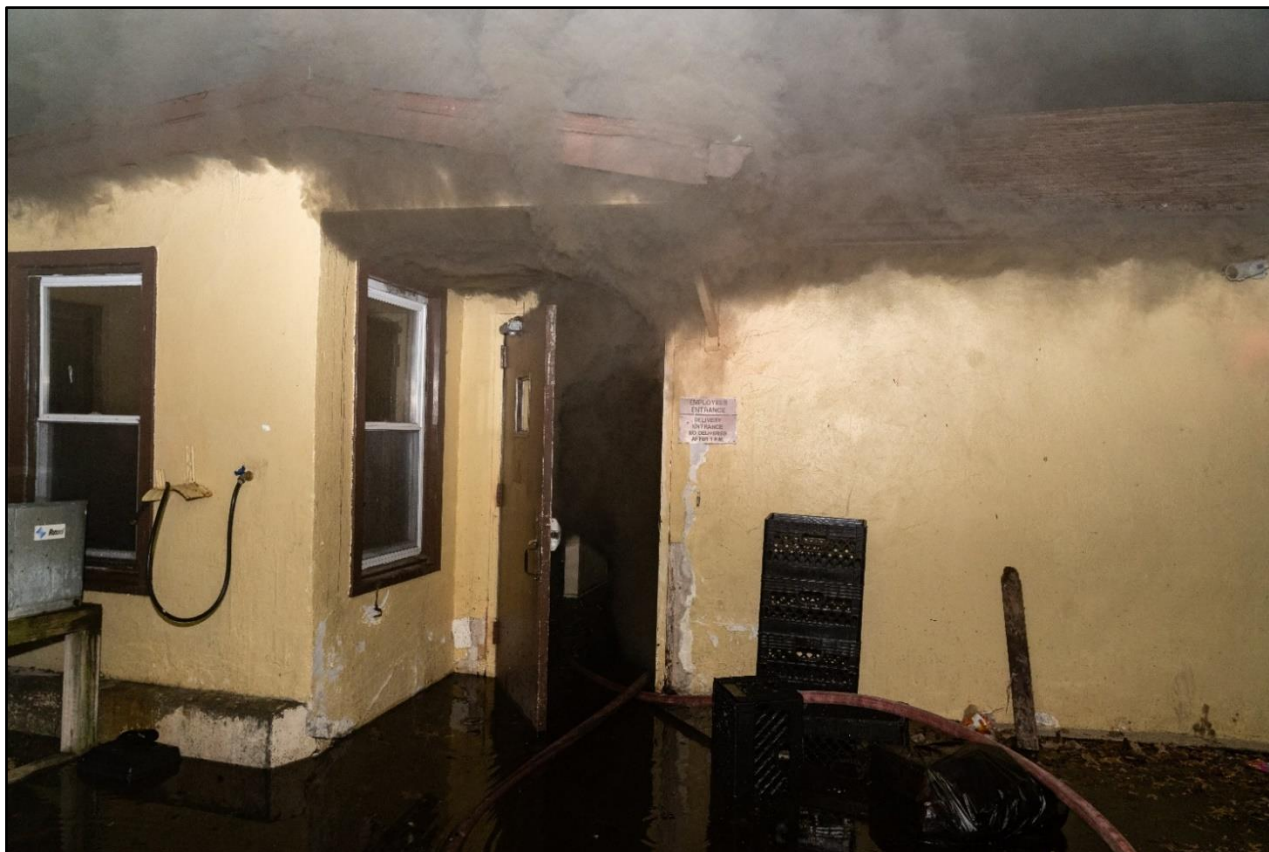
Photo 5. The smoke conditions from the exterior dairy kitchen door on Side Alpha. The 1¾-inch hoseline was from Tanker 17. The time is approximately 01:40 hours.
(Photo courtesy of Kenneth Flynn)

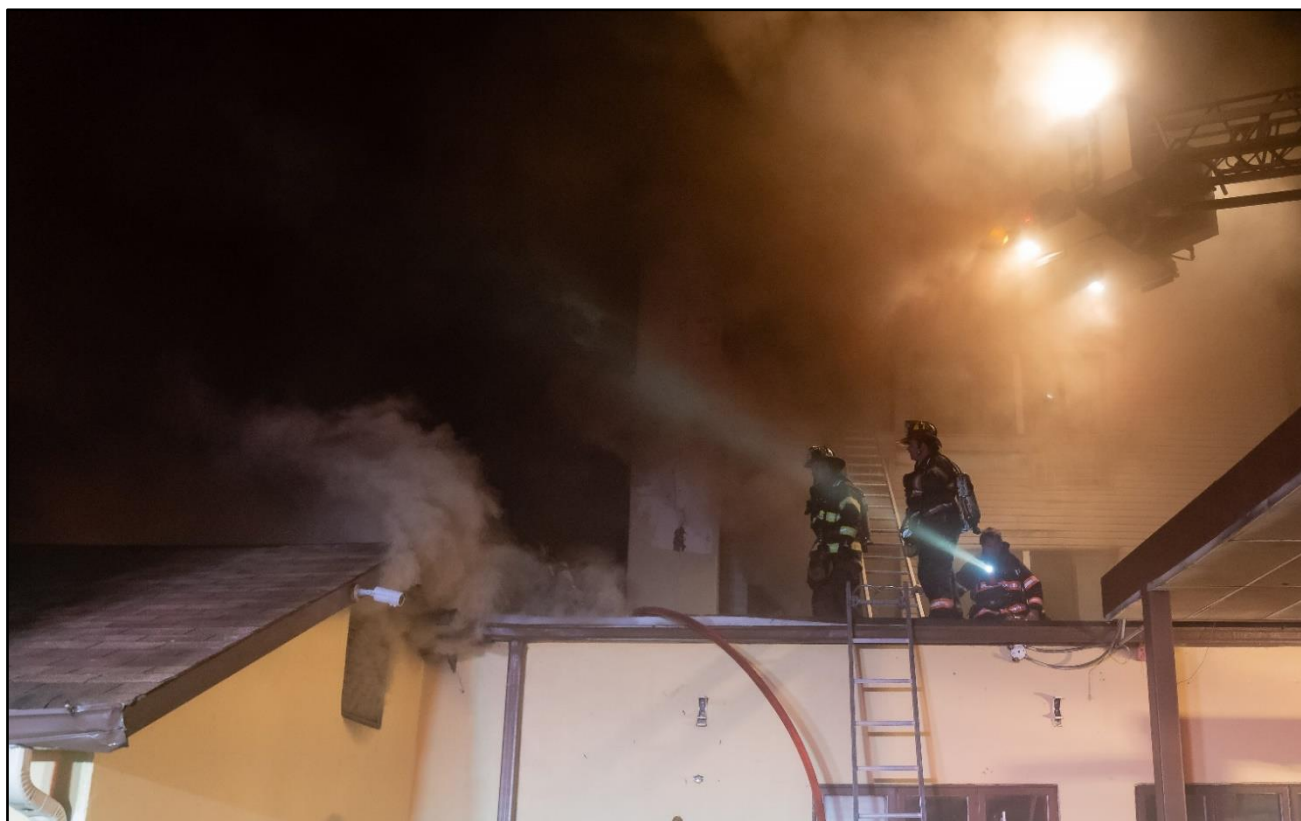
Photo 6. Firefighters using a ground ladder and Quint 17 trying to reach the occupant in Room 306. The time is approximately 01:51 hours.

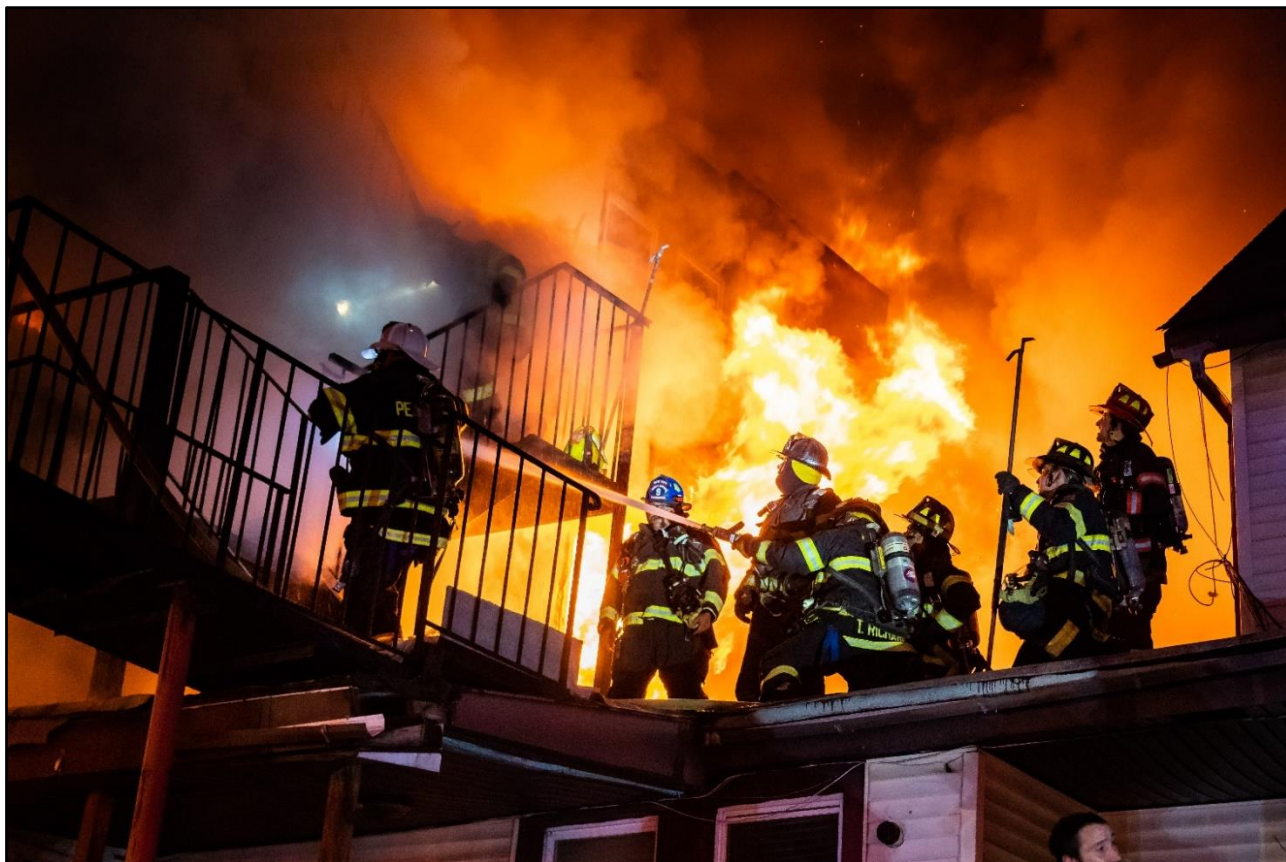
Photo 7. Firefighters on dairy kitchen roof using a hoseline to protect firefighters coming down from fire escape, 02:00 hours.
(Photo Courtesy of Kenneth Flynn)

At 01:57 hours, crews from Fire Department 17 radioed to Command that they were on the dairy kitchen roof with a hoseline into the 2nd floor. There was also a fire showing from the natural gas line, which was located on the dairy kitchen roof. They requested either a 2½-inch hoseline or a ladder pipe from the truck to hit the kitchen fire. At this time, firefighters from Fire Department 9 found the civilian victim from Room 306 and began to move him towards the fire escape on the Side Bravo/Side Charlie corner. At 01:58 hours, Command requested all units to clear the radio and asked if anyone had seen the missing firefighter from Fire Department 17 (Tanker 17D). FAST 24 radioed Command they had lost water to the hoseline on the dairy kitchen roof. At 01:59 hours, a firefighter from FAST 24 radioed that the missing firefighter was Tanker 17D. Fire Department 9 firefighters had the civilian victim from the 3rd floor at the Side Bravo/Side Charlie corner. They requested EMS meet them at the bottom of the fire escape. Command requested all chiefs on-scene to perform a PAR of their individual fire departments. Command radioed Tanker 17D and then requested all units on-scene to report if they see Tanker 17D. At 02:00 hours, FAST 24 made another request for water. Other units radioed that they were trying to locate a different fire hydrant to establish a water supply. At this point, fire was visible from the 2nd floor fire escape door and windows. Firefighters from Fire Department 9 descended the fire escape with the civilian victim from Room 306. Firefighters on the dairy kitchen roof were directed to use a hoseline to protect the firefighters coming down the fire escape (See Photo 7).

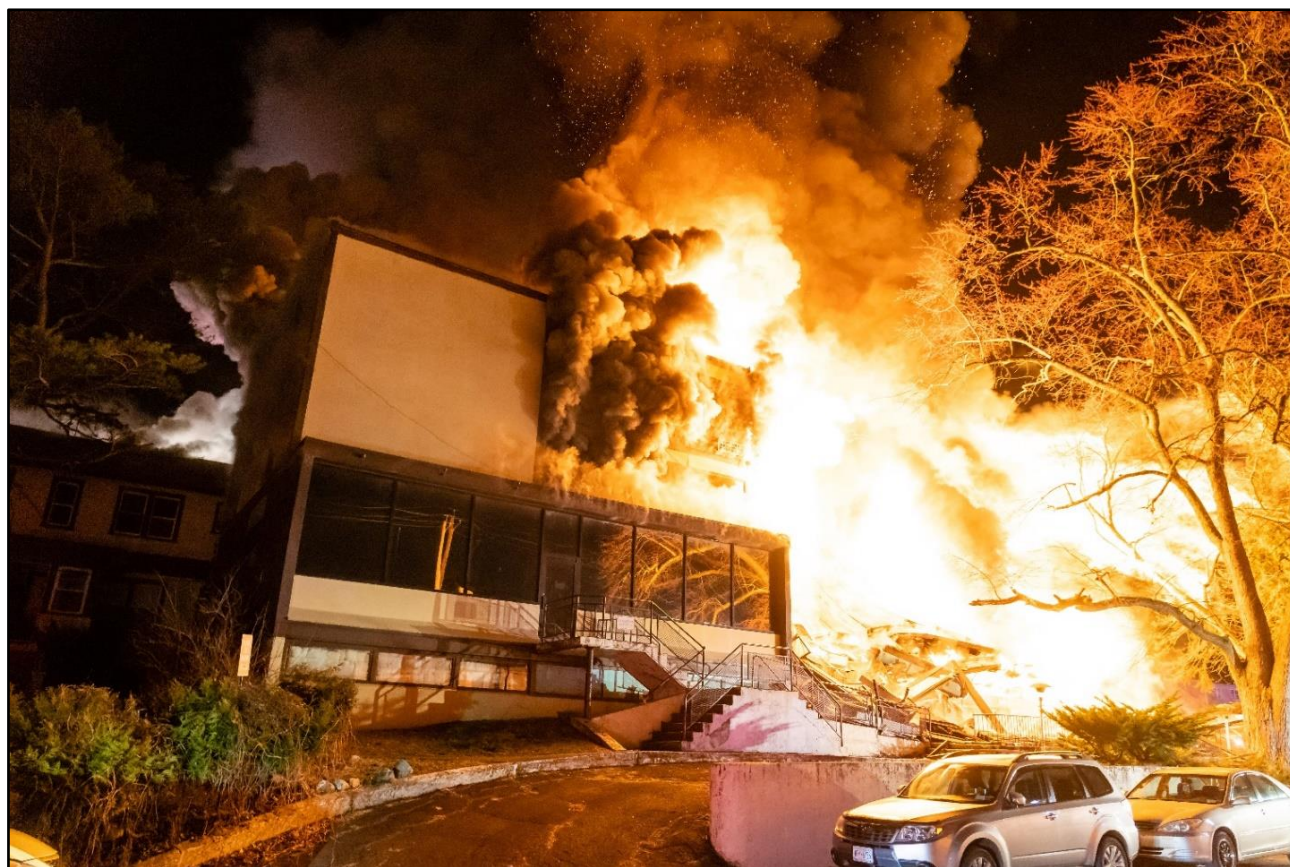
**Photo 8. The cantilever collapse of Side Bravo/Side Charlie corner of the original building. The time was approximately 02:08 hours.
(Photo Courtesy of Kenneth Flynn)**

At 02:01 hours, Command again requested if anyone on the fireground had seen Tanker 17D. 44 Control radioed Command that all fire departments had been operating on-scene for 60 minutes. At 02:04 hours, units radioed that they were still trying to establish water from the hydrant as 17-4 reported to Chief 17-1 that the 2nd floor of the facility had collapsed. Tanker 17A is thrown from the collapsing dairy kitchen roof and subsequently transported to a local hospital for medical treatment. At 02:05 hours, Fire Department 15 arrived on-scene. 44 Control advised the following fire departments were on-scene: 17, 6, 7, 8, 9, 12, 19, 20, 24, 25, 13, and 15. Command acknowledged and advised that one firefighter was unaccounted for and missing. At 02:07 hours, an *Urgent* was called for a major collapse on Side Bravo and Side Charlie of the facility. A cantilever collapse was witnessed with part of Side Charlie of the structure remaining standing (See **Photo 8**).

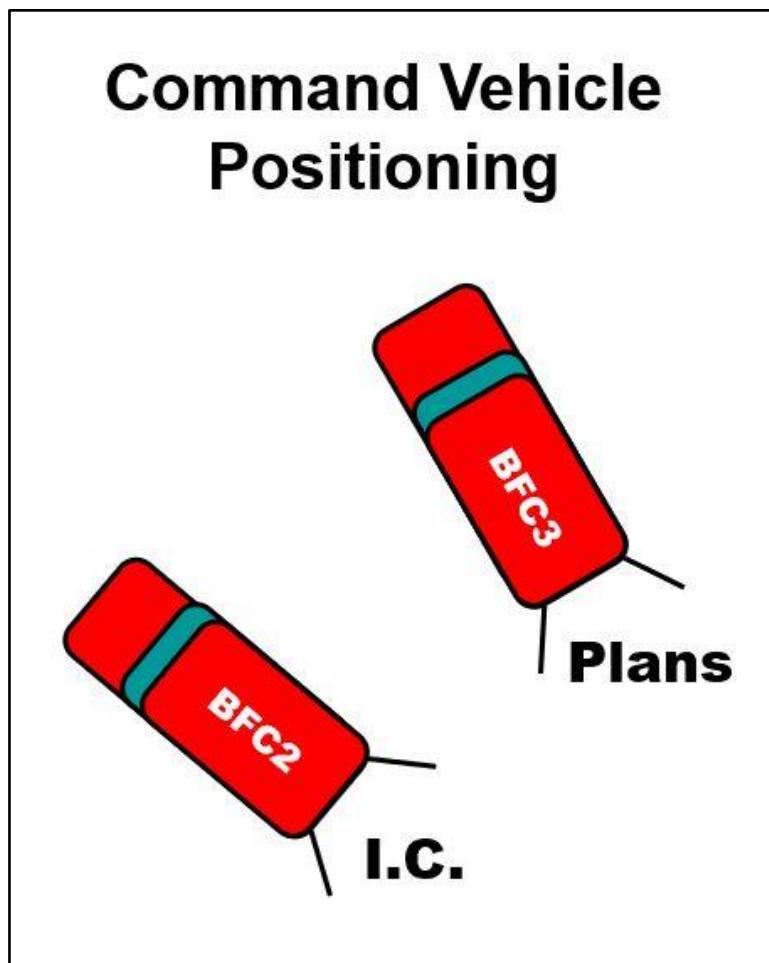
Figure 1. An example of utilizing a Planning Section Chief who is working in proximity with the IC at a Type IV incident. Also, another command vehicle can be added for the Logistics Section Chief.

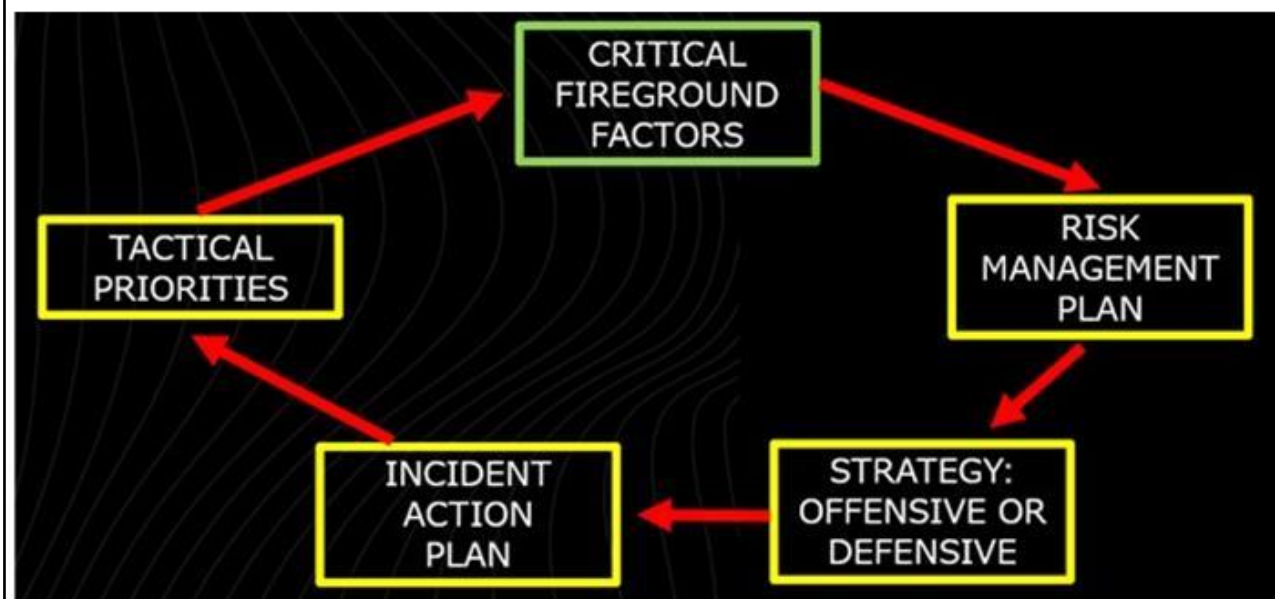
Diagram 2. This model displays the decision-making process into a standard sequence.
(Courtesy of South King County Fire Training Consortium)
